The LabView Enabled Watershed Assessment System (LEWAS)

An NSF Transforming Undergraduate Education in STEM (TUES) Project:
Dr. Vinod Lohani & Dr. Randy Dymond, PE

Project Title: *Integration of a Remote Water Sustainability Lab to Enhance Undergraduate Engineering Education*

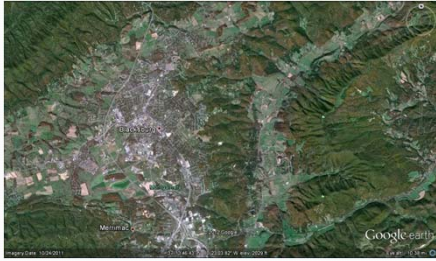
Google Earth image (24 Oct 2011) of Blacksburg and surrounding area, showing dichotomy between urbanized and non-urbanized areas.

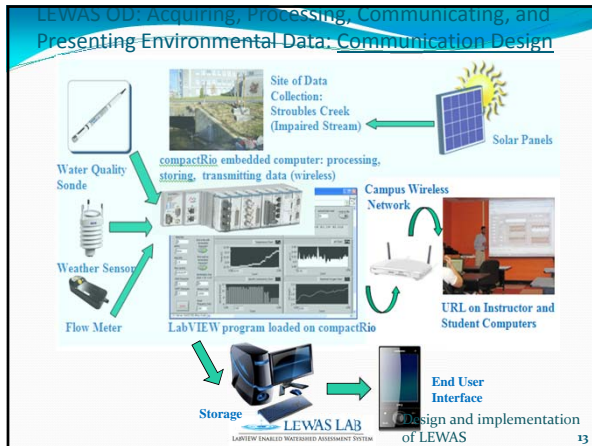
LEWAS Sensors and Measured Parameters

- Water Quality Sonde
 - pH, Dissolved Oxygen, turbidity, specific conductivity and Temperature as indicators of stream health
- Acoustic Doppler Current Profiler
 - Water flow as indicator of type of land use and stream health
- Weather station
 - Barometric pressure, humidity, precipitation, wind speed and direction

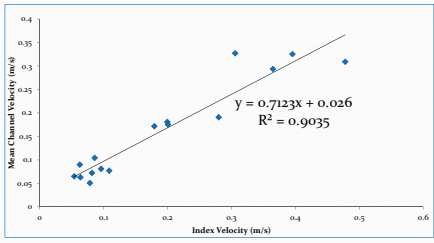
Figure 1. Regression of mean channel velocity (from step 1) and index velocity (from step 2).

Regression Equation for Mean Channel Velocity (V_m) vs. Index Velocity (V_i)
